Memorandum

Subject: Regional Analogs to Proposed Restoration of Miller Creek, Grady Ranch, Marin County, California

PHOTOS OF RESTORATION AT LUCAS VALLEY ESTATES

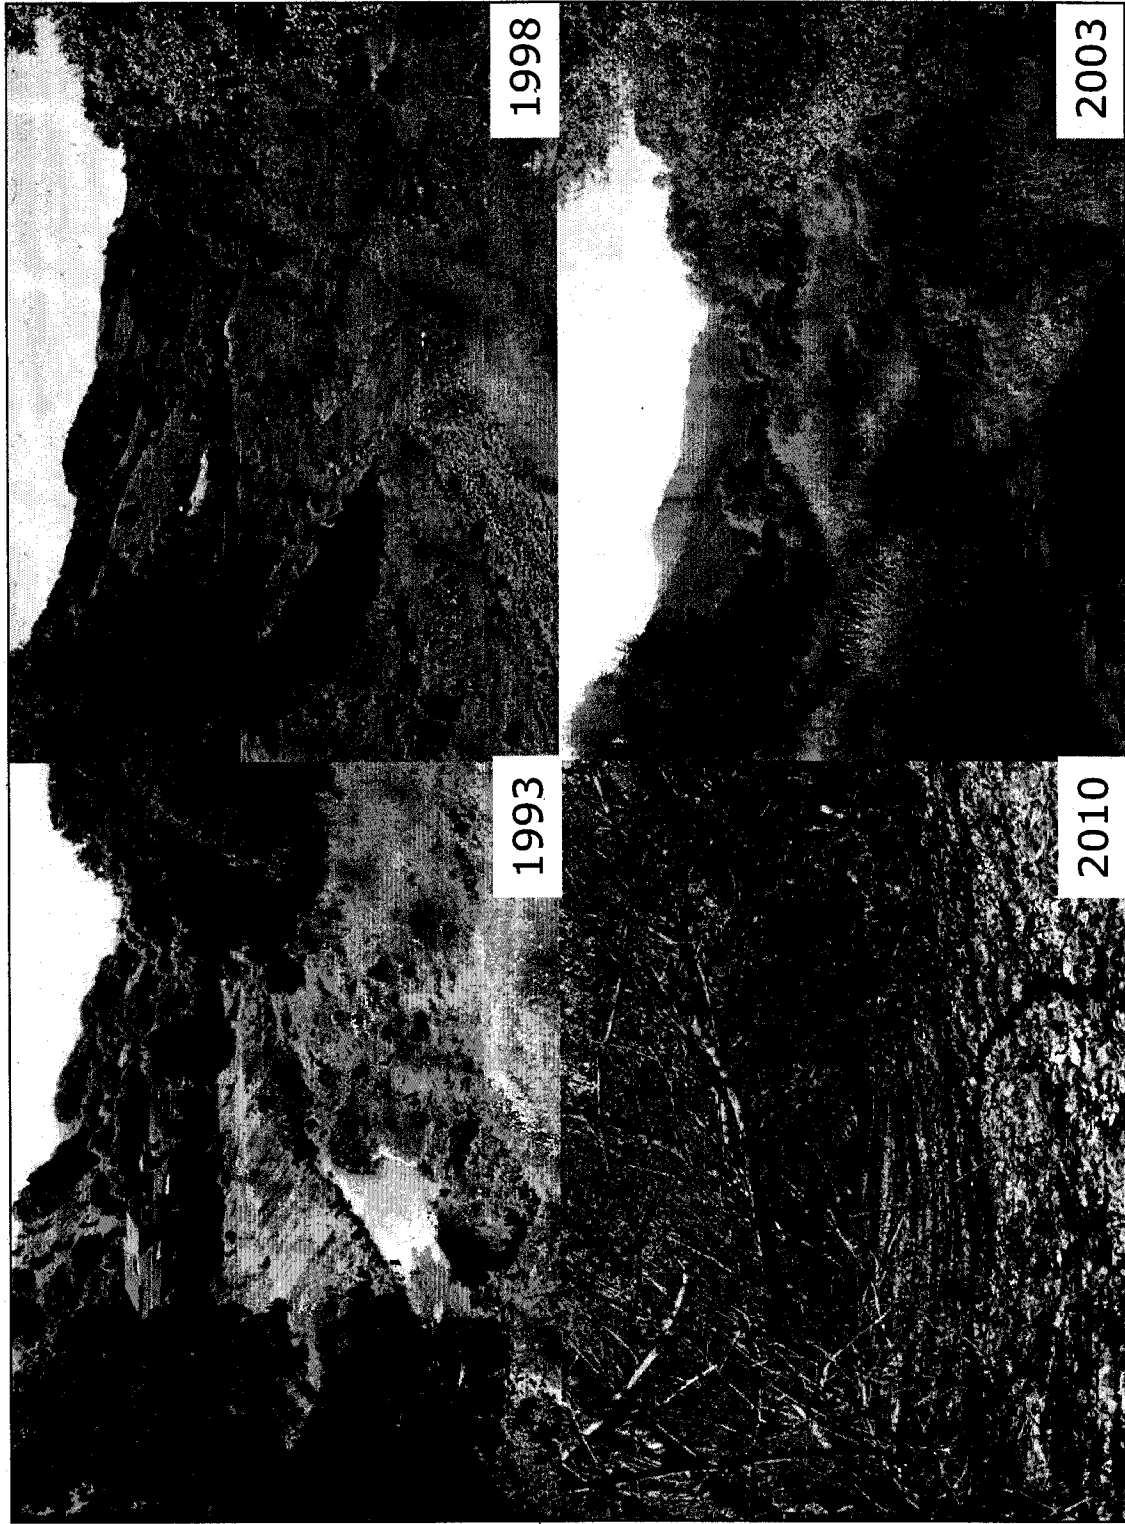
Figure 5. Floodplain design in Lucas Valley Estates reach of Miller Creek, Marin County, California. Source: Yin and Pope-Daum, 2004

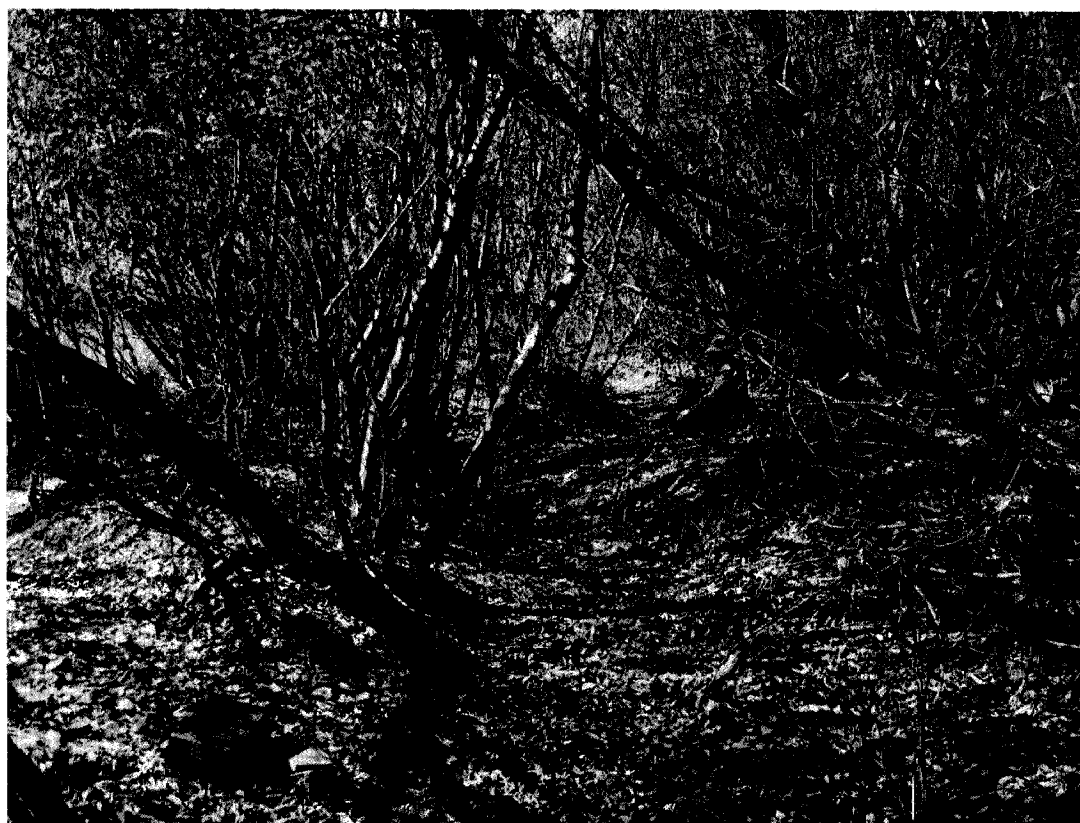
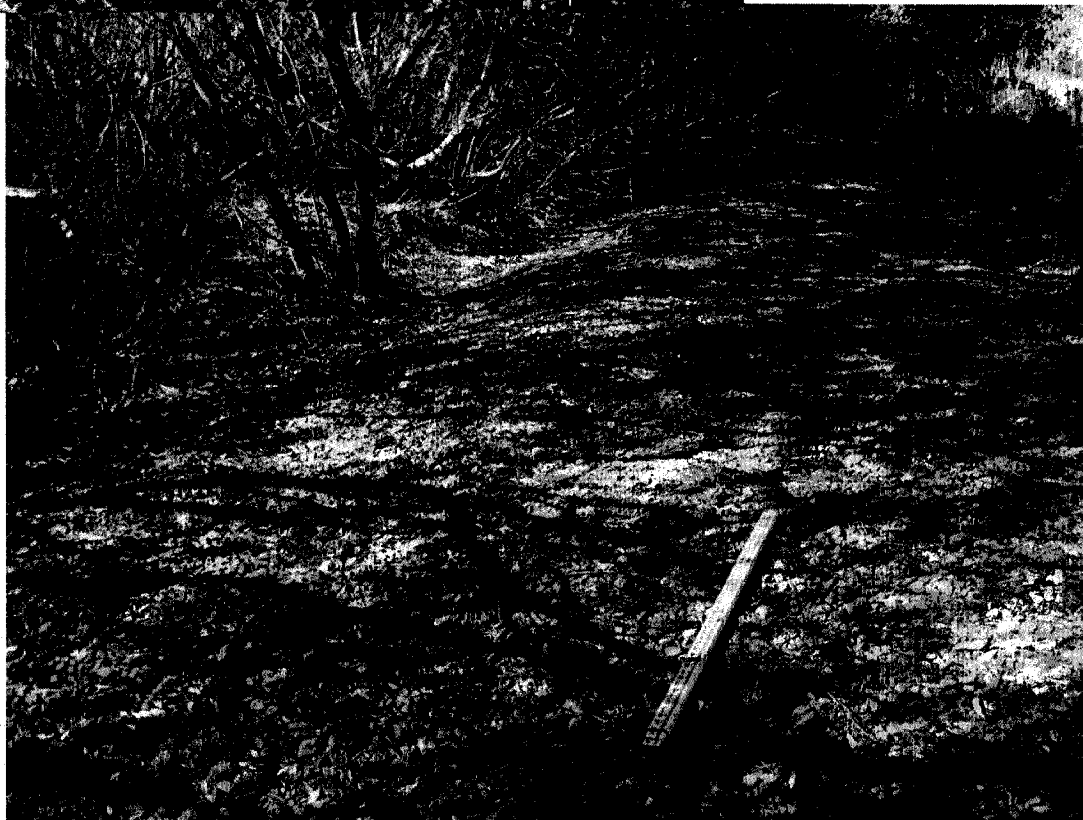
Figure 7. Tributary channel stability in Lucas Valley Estates reach, Marin County, California. Boulder-weir check dams were installed as part stream restoration to arrest incision.

Looking further
upstream

Large bar upstream
of community park

In addition, it is important to note that the boulder weirs that were installed as part of the Lucas Valley Estates restoration remain stable, and have effectively held grade in the upstream reaches (Attachment A, Figures 7 and 10).

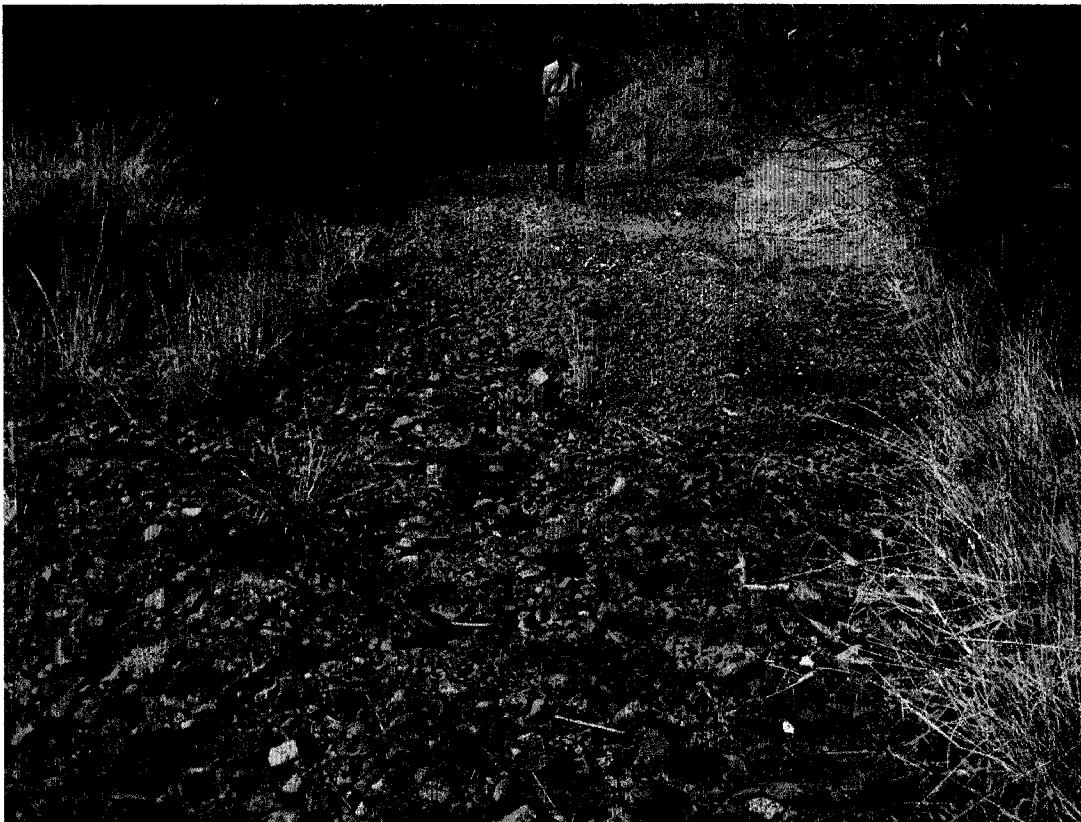
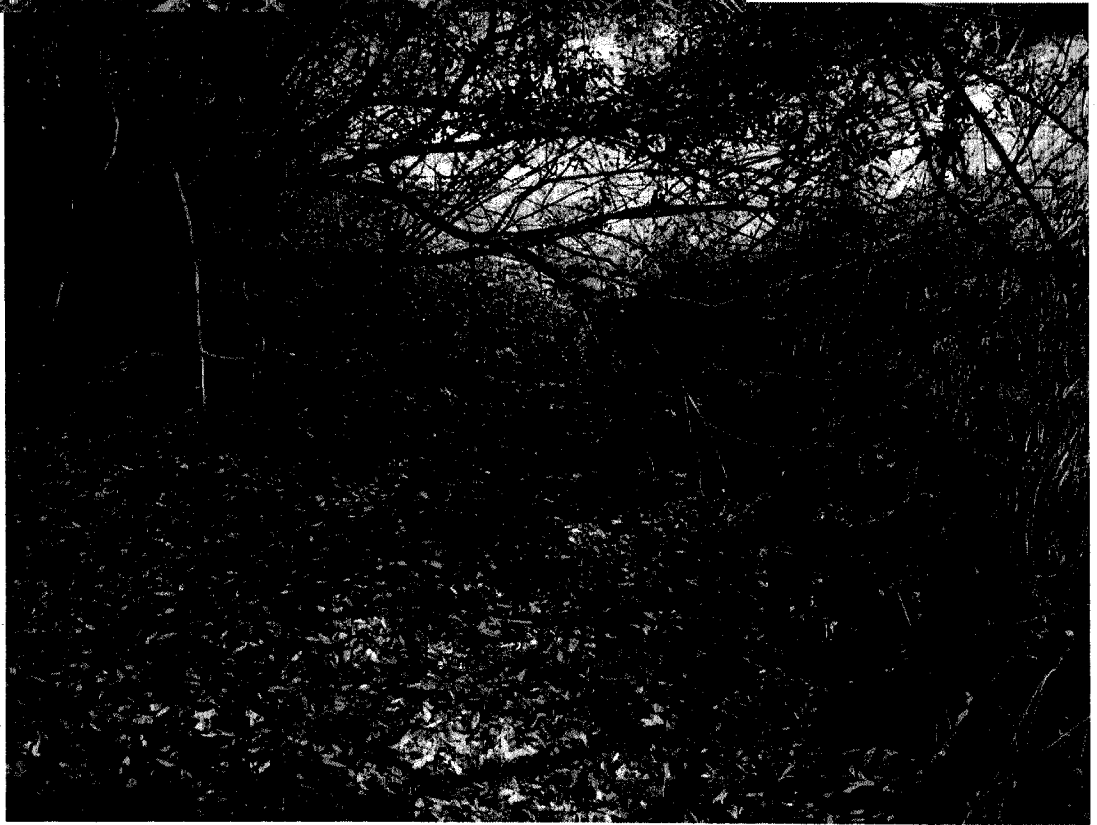
Figure 8. Miller Creek in Lucas Valley Estates reach, upper portion of creek restoration, Marin County, California. Sediment storage and willow thickets are abundant, and an alternate channel with bar-pool morphology typical.

Re-worked stream bed
near community park

Downstream of
community park
(looking upstream)

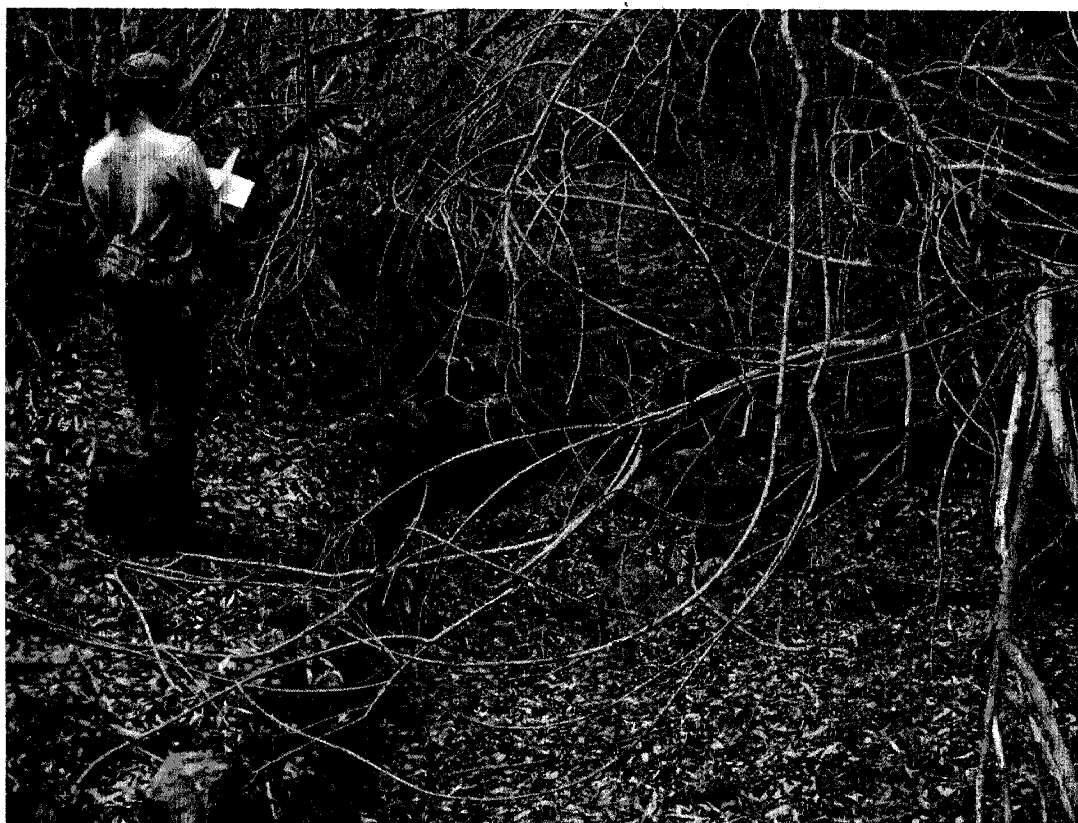
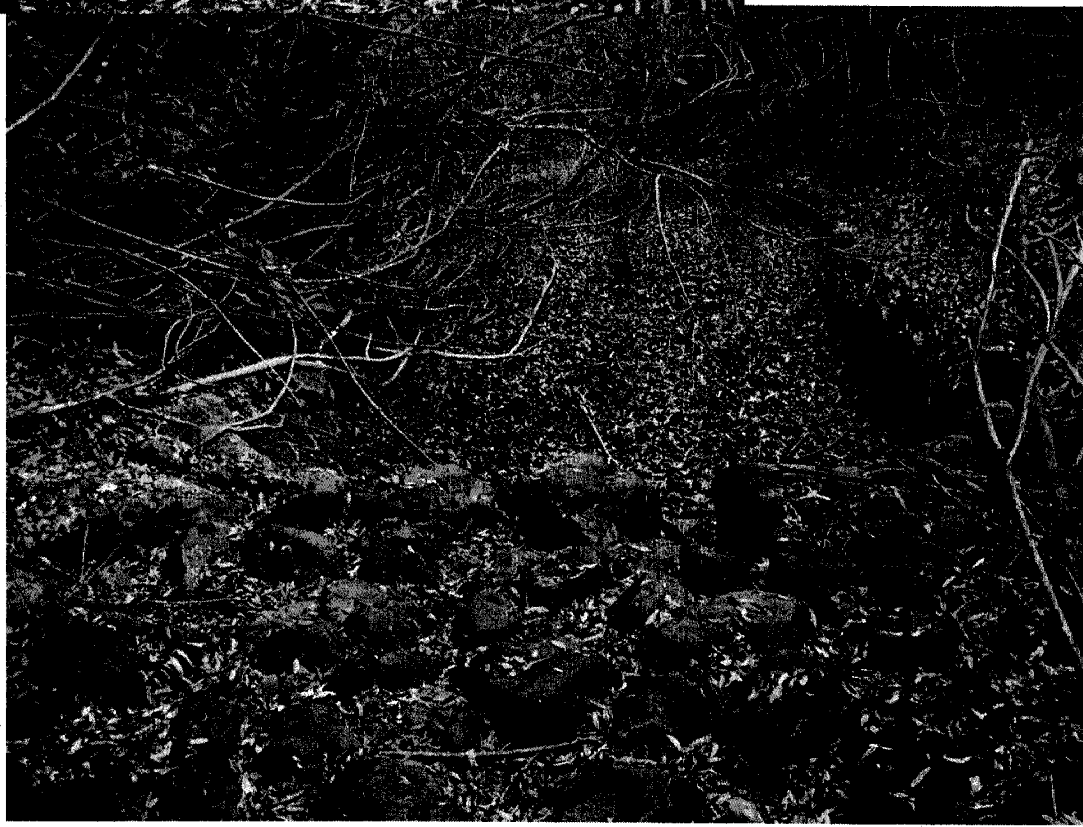
Figure 9. Miller Creek in Lucas Valley Estates reach middle portion of creek restoration, Marin County, California. A re-worked bed and designed channel cobble/boulder banks are key features since restoration.

Looking upstream

Looking downstream

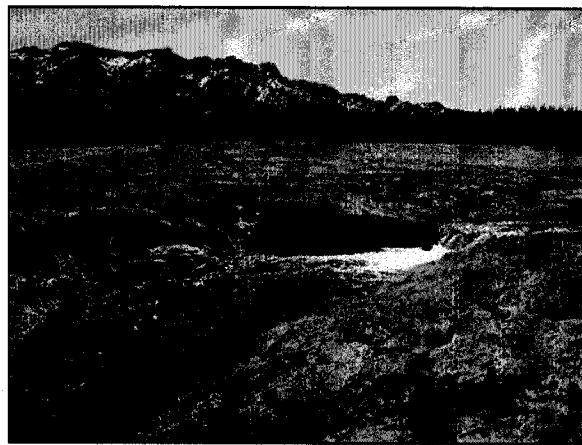
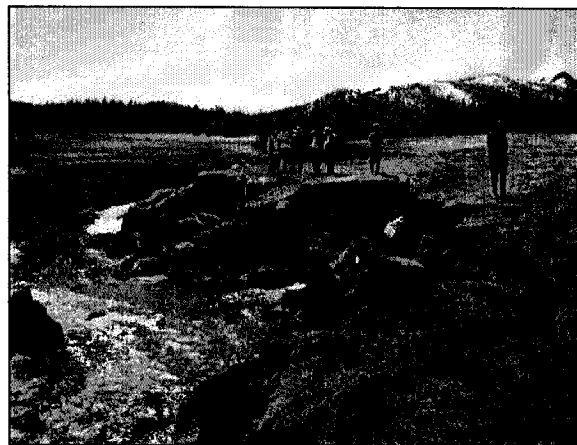
2) **Improve water quality and streambank protection:** No water quality data were collected, however, sedimentation was reduced due to elimination of headcuts. Sedimentation from widening vertical raw banks was also eliminated. These outcomes are visible in the following

sets photos. Post-project photos on the left were taken in spring 2008, before the first growing season. Pre-project photos on the right were taken in spring 2006.

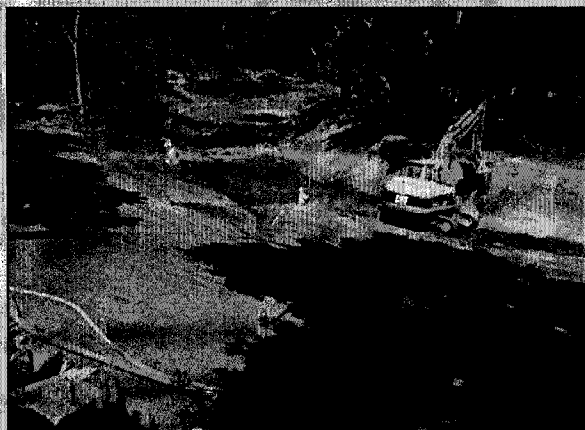
Construction of new stream
